FIFTH QUARTERLY REPORT ON
MANUFACTURING METHODS AND ENGINEERING
FOR TFT ADDRESSED DISPLAY

May 7, 1977 to August 7, 1977

CONTRACT DAAB07-76-C-0027

WESTINGHOUSE INDUSTRIAL AND GOVERNMENT TUBE DIVISION
WESTINGHOUSE CIRCLE
HORSEHEADS, NEW YORK 14845

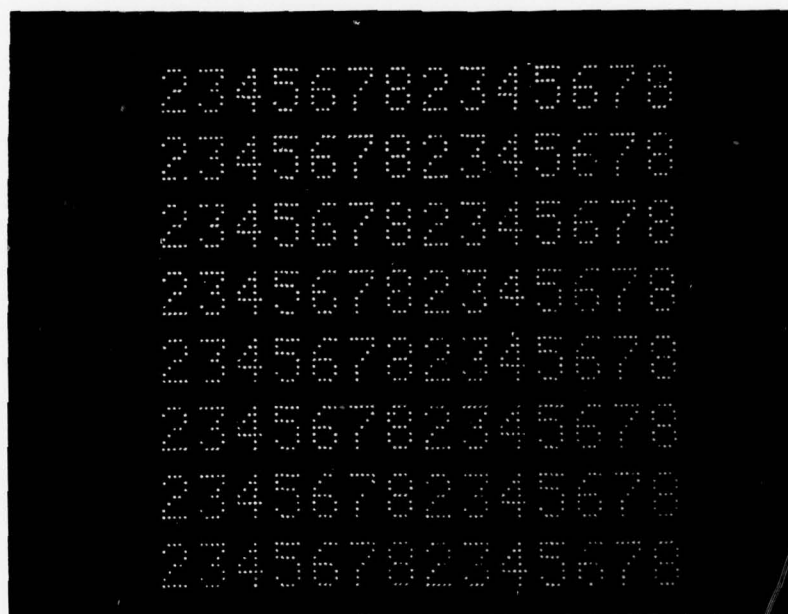
FIGURE 1

The first objective of this program is to move a technology out of the laboratory and into (pilot) production. That this is actually being accomplished is proved by a photograph of an actual DMD substrate produced in the pilot facility in July (Figure 1). This is not only comparable in quality to the best units made in the laboratory, since the pilot facility has demonstrated significant repeatability, it promises to be not an "accident", but the beginning of quality production.

BEST DMD SUBSTRATE PRODUCED IN PILOT FACILITY

Moving technology out of the laboratory and into (even pilot) production is a difficult and time-consuming task. With the latest substrate (Figure 1), it now appears that the first and probably most difficult portion of the work -- achieving equivalent quality product -- is being achieved. Other very significant objectives remain, however: higher quality, high yield, reasonable throughput and reasonable cost. The first two of these will be the subject of efforts during the next several months. In particular, cleanliness improvement will probably be a prime objective for (at least) many months to come. Repeatability must be improved to achieve high yields, particularly in the areas of improved tooling, especially masking, and deposition techniques and procedures. Cleaning procedures still need to be improved. Mask inspection techniques need to be devised to permit detection of small particles. None of these, however, appears insurmountable in light of the problems which, demonstrably, have now been overcome.
